## WORK AT KALENDERHANE CAMII IN ISTANBUL: FIFTH PRELIMINARY REPORT (1970-74)

CECIL L. STRIKER and Y. DOĞAN KUBAN

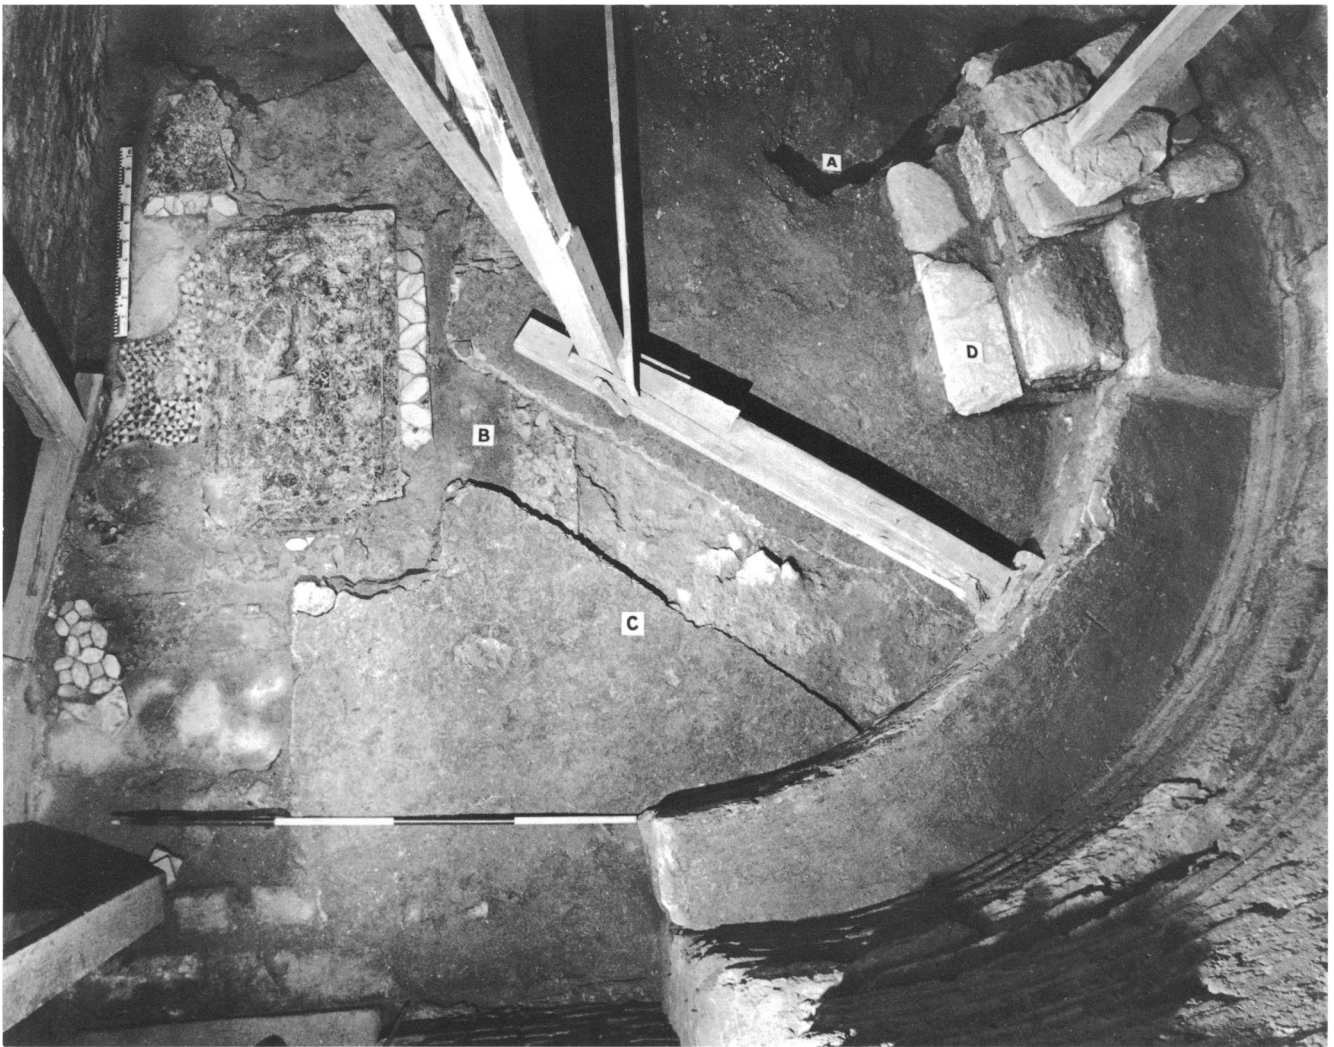
1. Early Byzantine Basilica, Apse Excavation (North at Top)

The excavation of the apse revealed features that left no doubt that the building of which it was a part was originally built as a church (figs. A and 1). The flanks of the apse were opened by two doors, one to the south now communicating with the prothesis of the later church, and another to the north. Since the north flank of the apse was built directly against the Valens Aqueduct, passage through the north door was made pos-

The center of the apse wall is opened by a single window, and below it, extending originally to returns in the apse flanks, was a single-step synthronon. Its north arm had been subsequently destroyed and its central element overbuilt in Turkish times; but the south arm is preserved intact. It consists of a simple bench of mortared rubble construction covered with a mortar slip. Doubt may be raised as to whether this was its original appearance, for although some evidence indicates the synthronon to be part of the original furniture of the apse, there is secure evidence that the apse walls were revetted throughout with marble. Perhaps the synthronon originally was similarly revetted.

Set into the floor of the apse between the doors is a rectangular marble slab of verde antico, marking the altar emplacement. The slab is decorated with a simple molded frame and shows the setting position at its corners for the altar legs. It is surrounded by a damaged frame and mosaic of *opus sectile* in simple geometric design with inset discs.

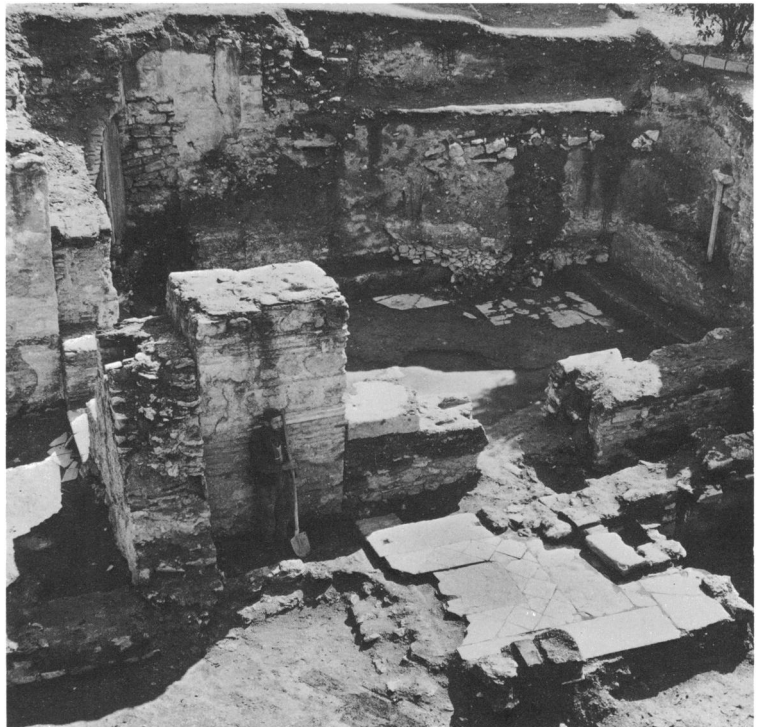
3. Southeast Exterior Excavation, looking Southeast

In the exterior zone to the south of the diaconicon, the grade level rises steeply to the east from approximately two meters to over five above interior floor level. This limited the extent to which excavation could be carried eastward. In F-G/9-10 (figs. A and 3) remains of a rectangular room were uncovered, lying in north-south axis and accessible by a door from the eastern end of the south aisle. The interior of the room measures 5 × 7.50 m. and is furnished with a bench running around its east, south, and west sides suggesting some assembly purpose. The room is secondary to the heavy reinforcing pier in F/9 and is thus presumed to be Palaeologan in date.

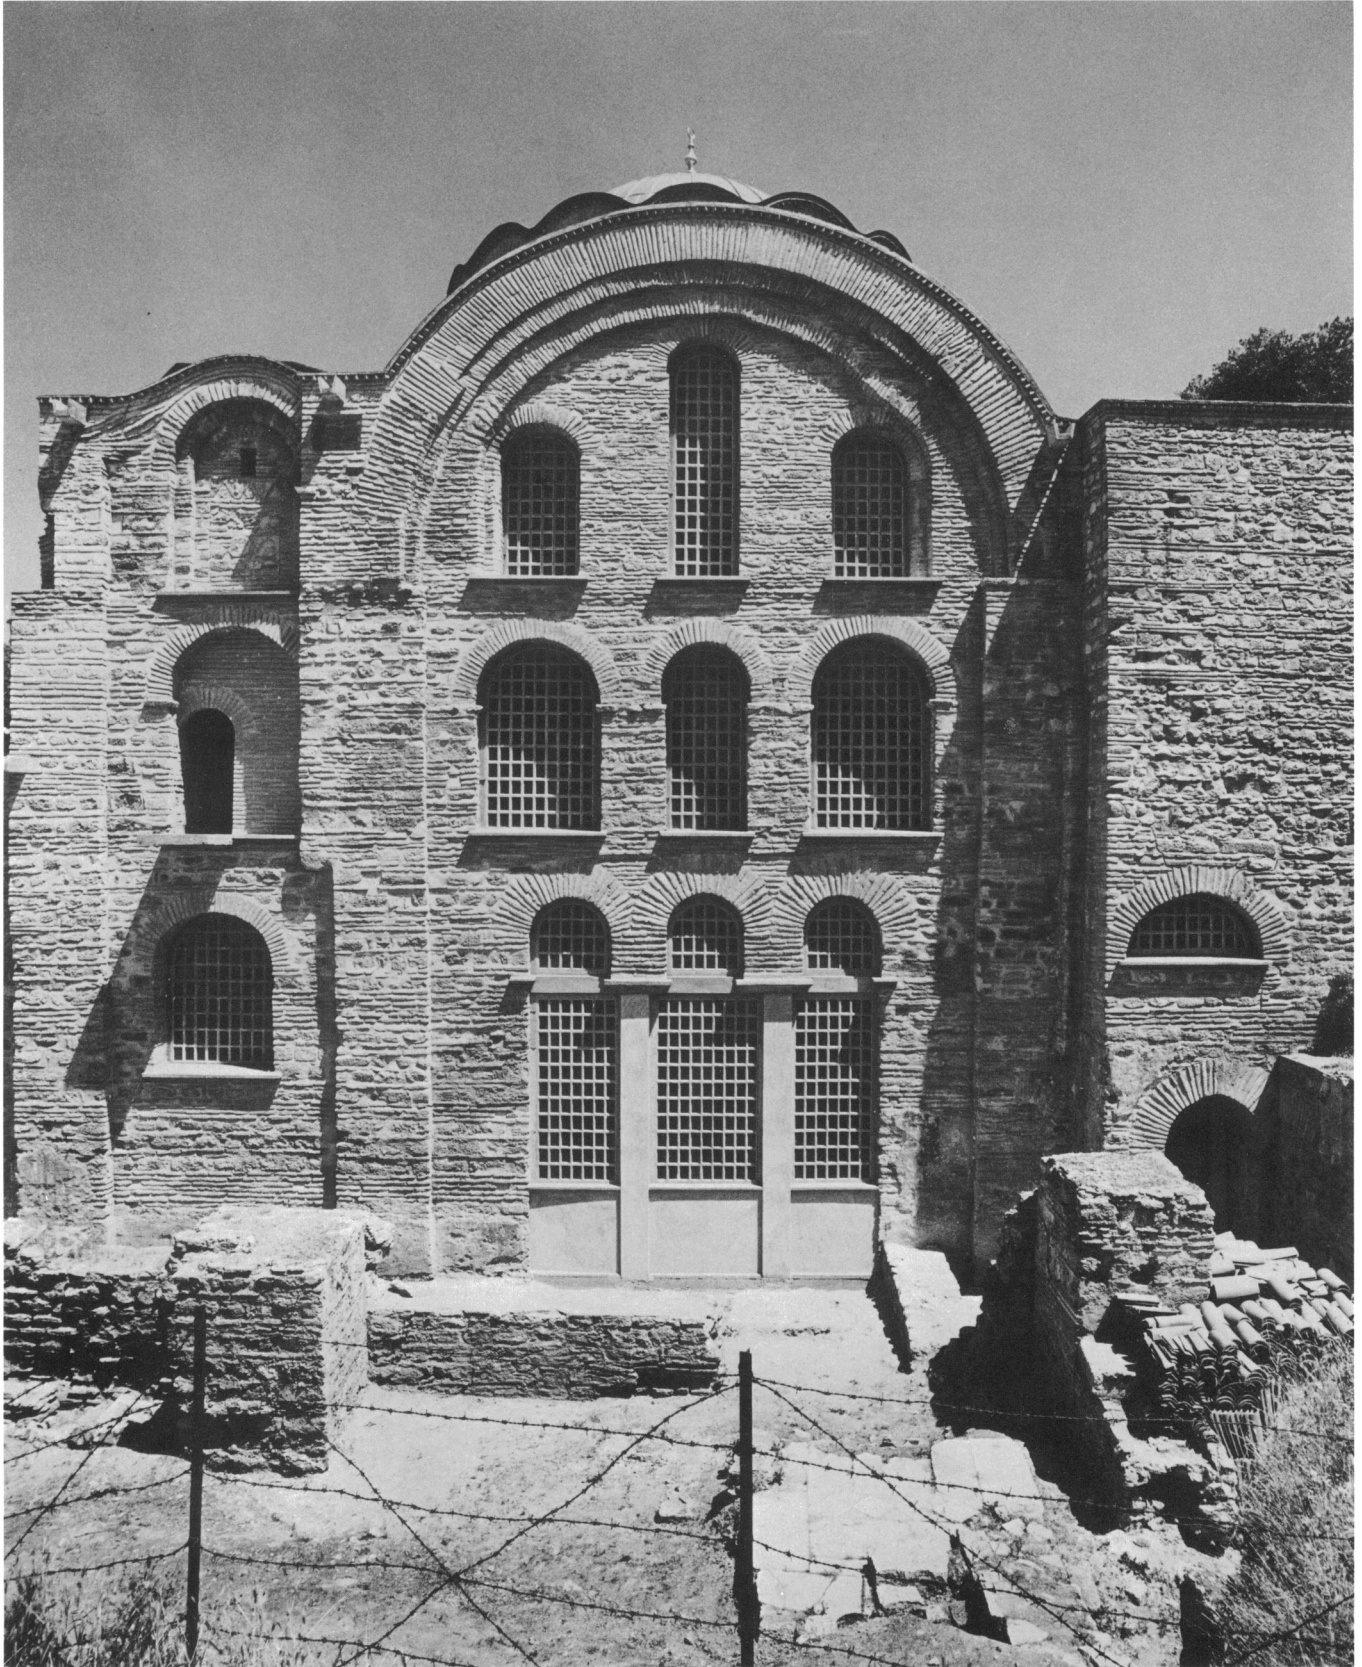
5. South Flank (1973)

So as to leave the tribeloi columns free-standing within the naos, while at the same time expressing their support function on the exterior, a reinforced concrete lattice screen of the same design as that of the windows was carried across the tribeloi directly outside the columns, resting on a dado. This was vertically divided by pilasters marking the position of the columns. Window casements were let into the screen from the interior (fig. 5).

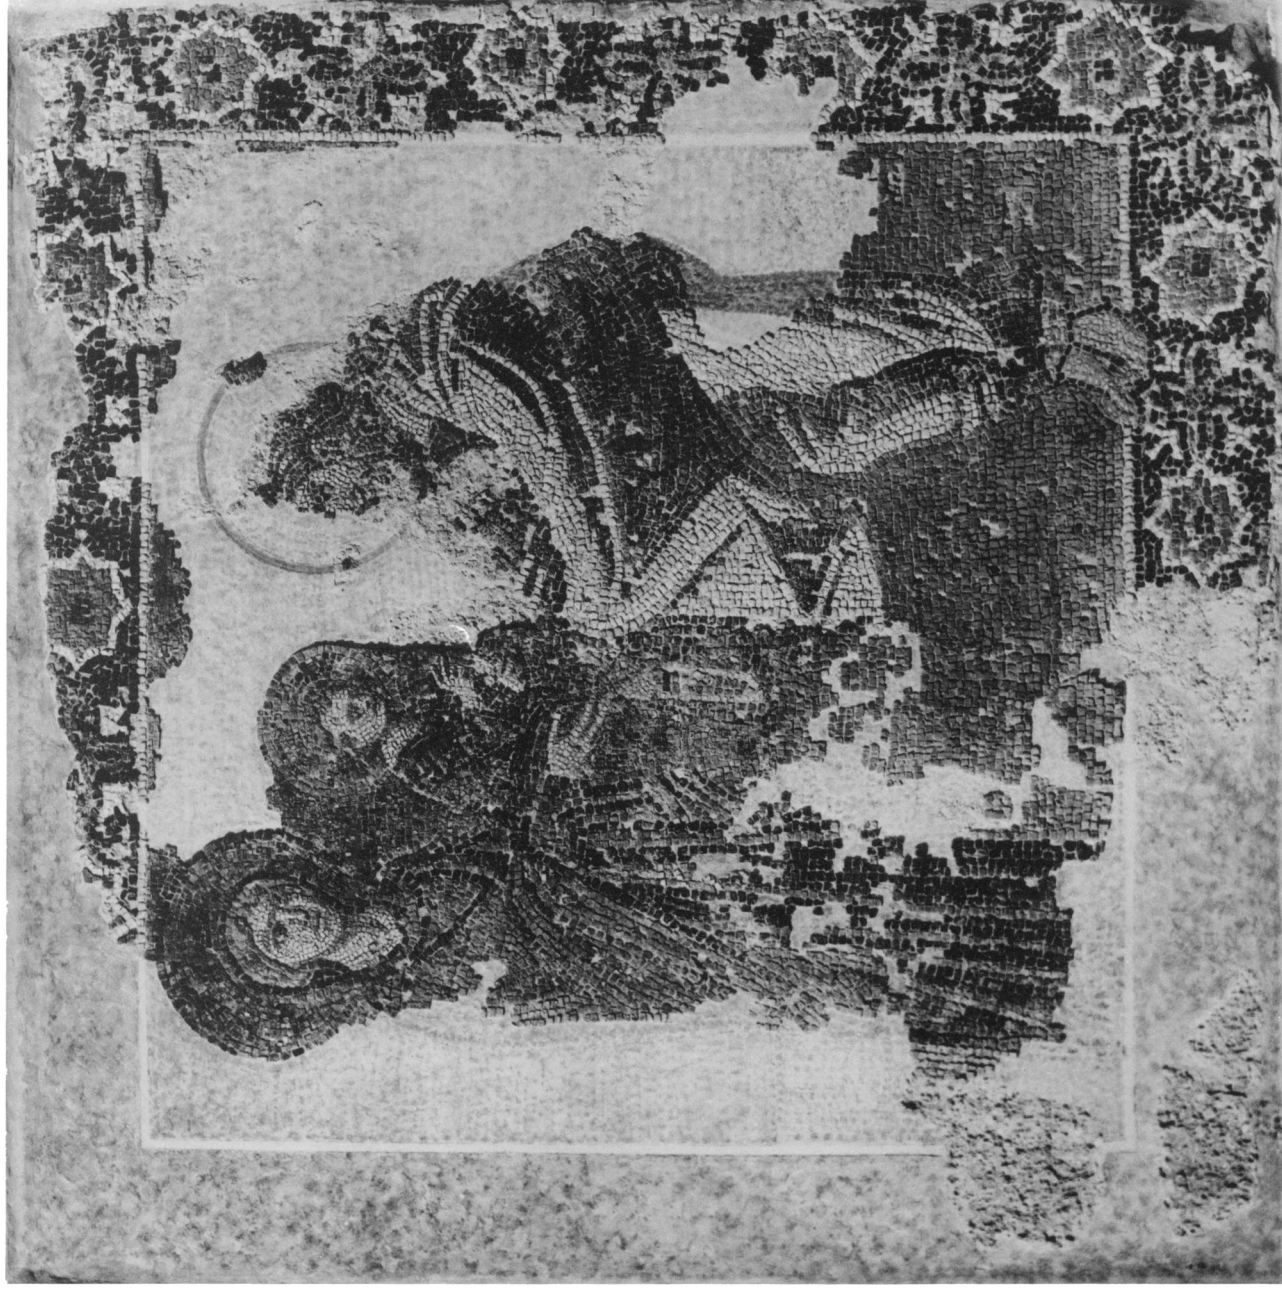
10. Mosaic of the Presentation in the Temple, after Restoration

The provisional backing affixed at the time of discovery was removed, and the setting bed thinned to within 5–8 mm. of the tesserae (fig. 8). The thinning revealed a vertical joint in the bed between the Virgin and Child group and Simeon, corresponding to the position on the face of the vertical line formed by the fall of drapery below Simeon's left wrist (fig. 10).

The mosaic was again turned face up and the packing removed. The areas of total loss were built up in gesso to form an even surface, and were in-painted in neutral stippling to harmonize and unify the composition (fig. 10). The tesserae were checked individually for bonding, and the mosaic surface given a final cleaning.

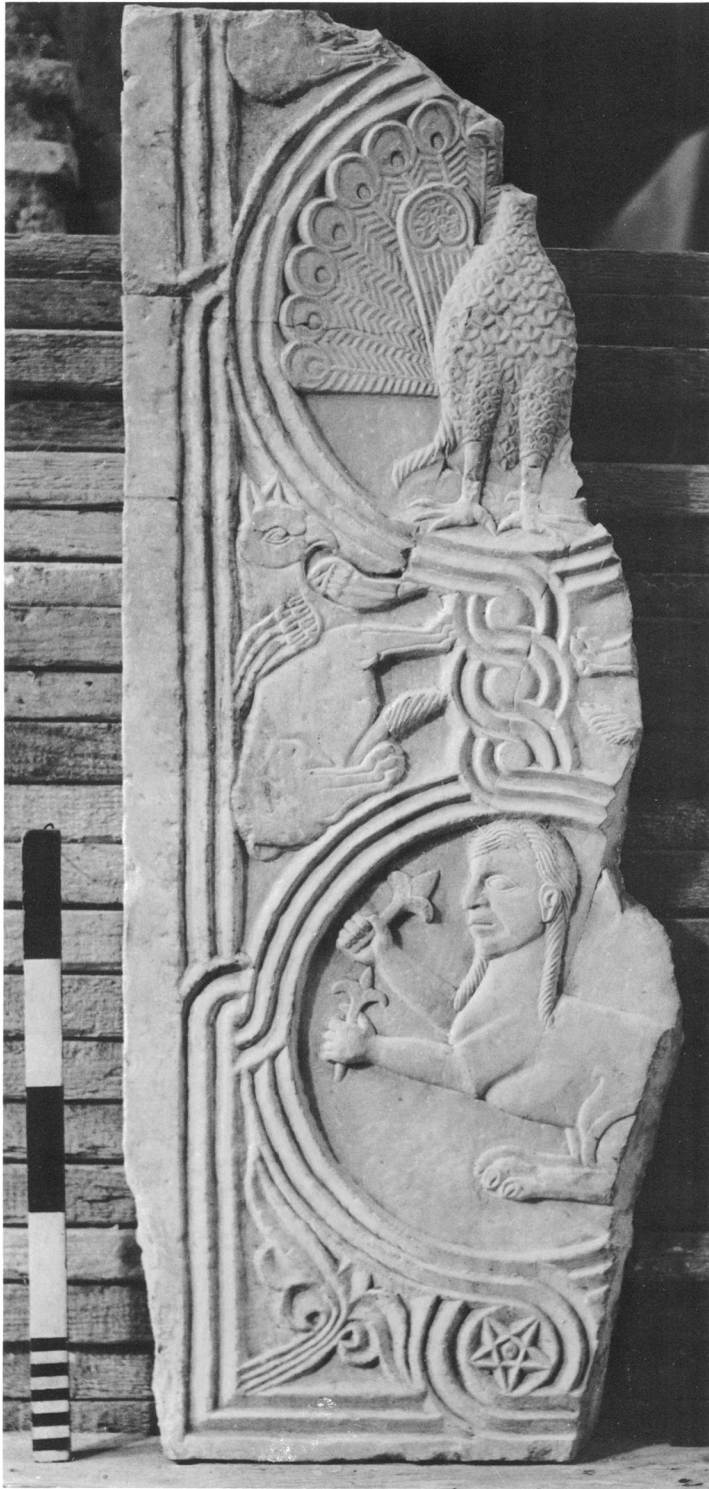
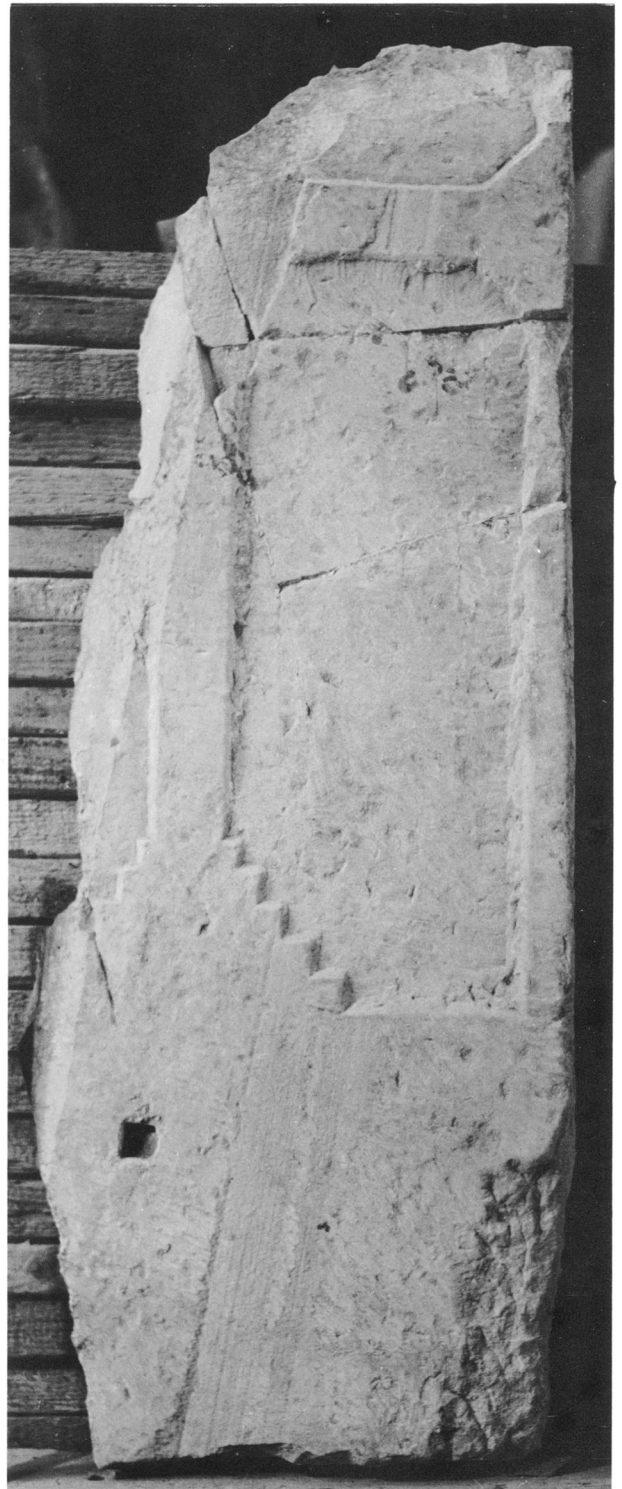
11. Steatite Icon Fragment of the Annunciation

a. Front

b. Back

10.4 cm. Estimated original dimensions, see comment below. Fractured on left side. Right side clean edge. Lower portion of Virgin seated on cushioned throne facing three-quarters left. Right hand crosses lap and holds distaff and two spindles. Throne rests on pedestal, is carried by turned legs, and has palmette decorated apron. Virgin is flanked to right by paired columns (from a baldachin) raised on pine-cone base topped by rectangular plinth.

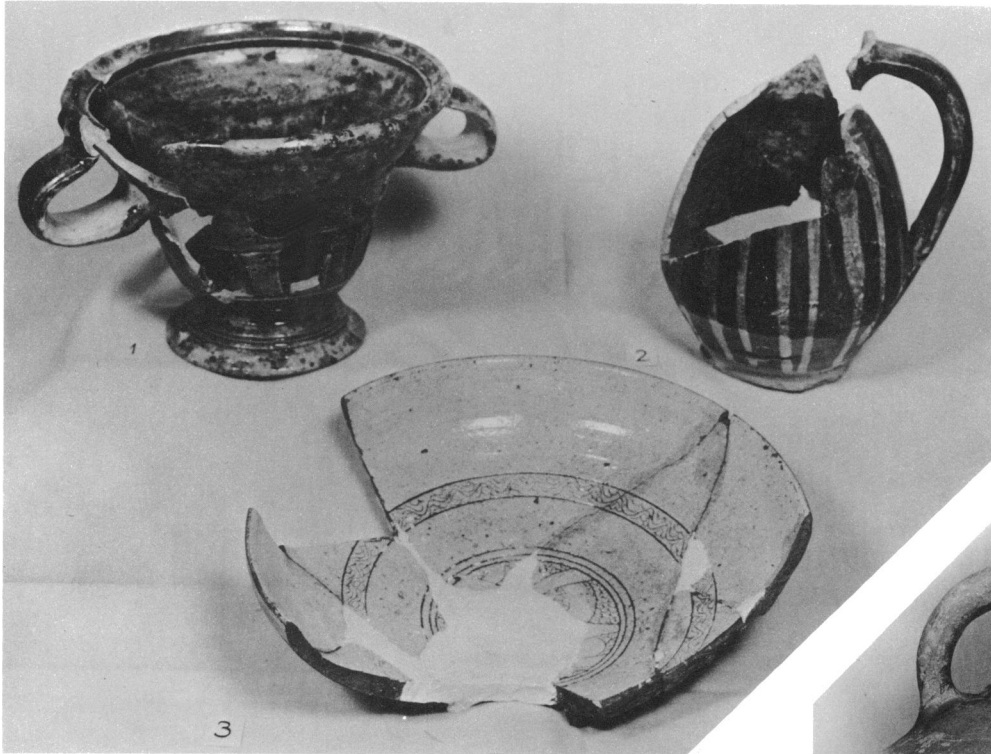
16. Eleventh- and Twelfth-century Wares (1:3)

Good examples of well-known types from this intervening period were also recovered, including polychrome wares, an almost intact eleventh-century chafing dish (fig. 16.1), a Corinthian ware bowl (fig. 16.3), and a twelfth-century slip-painted jug (fig. 16.2). For the most part, these were found as survival pieces in later contexts.

1. Chafing dish; two handles; profile complete; small part of rim, body, and burner missing; clover-leaf impression at inner center; dark green spattered glaze; white fabric; 11th cent. (ALA')
2. Jug: one handle; complete except for upper neck and rim and part of body; slip-painted; green glazed except for lower body; pink fabric; 12th cent. (AEK)
3. Plate: complete profile; parts of rim and body missing; Corinthian type; elaborate incised embroidery design through cream slip under glaze; red fabric; 12th cent. (AXW)

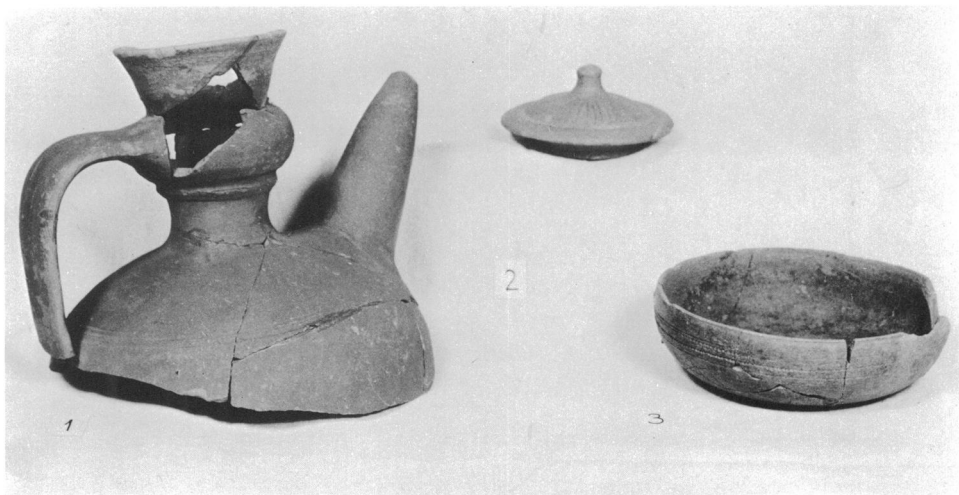
21. Seventeenth-century Burnished Wares (1:3)

A selection of red burnished seventeenth-century wares (fig. 21.1–3), probably of Istanbul-Tophane manufacture, extends our information on the use of this fabric beyond the well-known smoking pipes found in profusion on the site.

2. Lid: complete; buff fabric (BEZ)
3. Dish: complete profile; part of rim, body, and base missing; roulette decorated exterior; buff fabric (AUV)
